View of the 275 foot high State Department of Water Resources Building. Housed within this building are Dept. Of Parks & Recreation, Fish & Game, Water Resources District and the Dept of Forestry & Fire Protection.

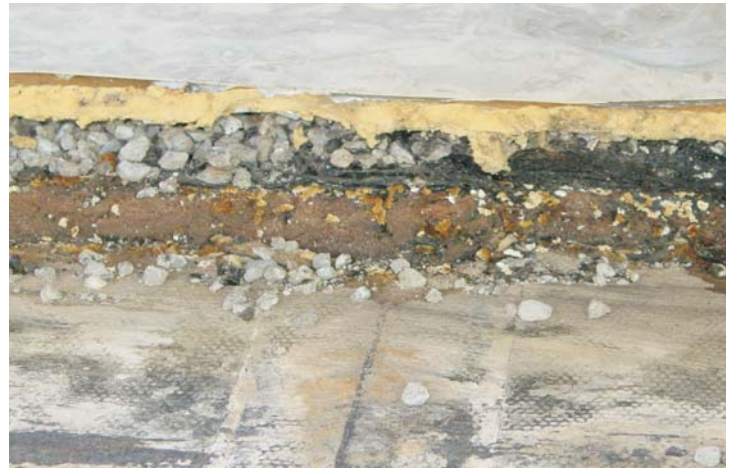
A test cut reveals a steel deck, followed by 1 ½" fiberglass insulation, followed by a 4 ply BUR set in hot asphalt with a gravel surfacing, followed by a recover board, followed by a PC membrane which was mechanically fastened to the deck.

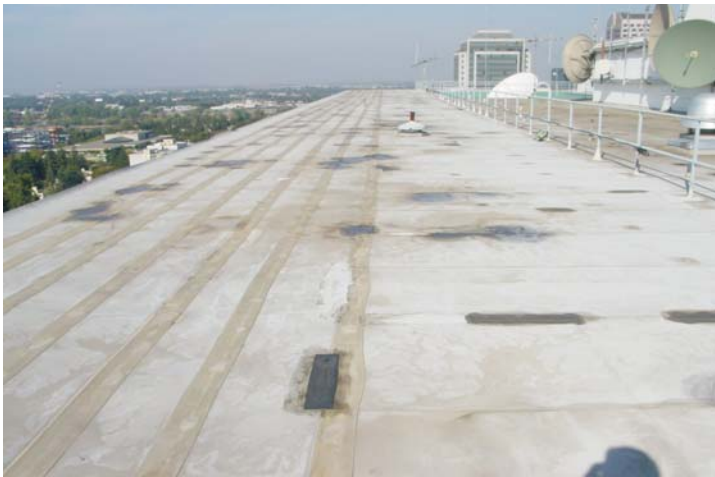
After years of high solar radiation, the plasticizers in the membrane began to bleed out. The membrane then became embrittled and began to shatter as it shrank.

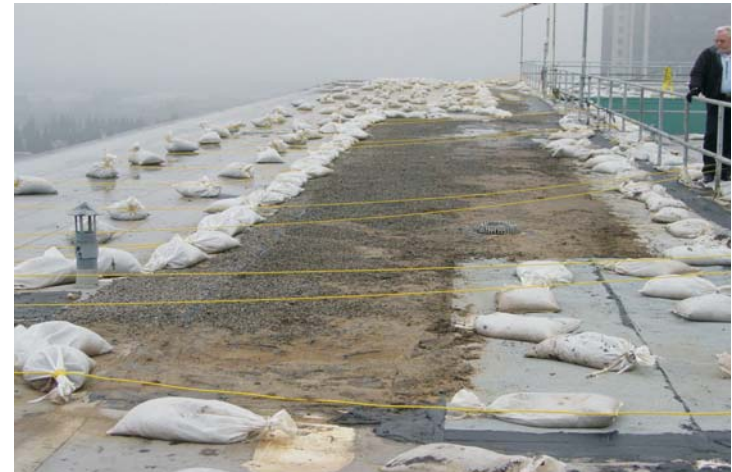
A large rain and wind storm caused a 2,000 square foot section of the PVC membrane to blow-off. The cause of this blow-off was due to wind getting under the southern perimeter metal edging.

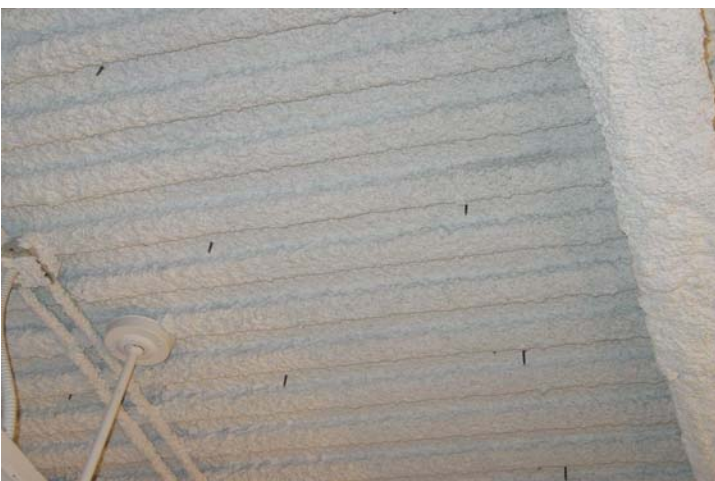
Examination of the lower side of the deck reveals a fire-proofing containing asbestos containing materials.

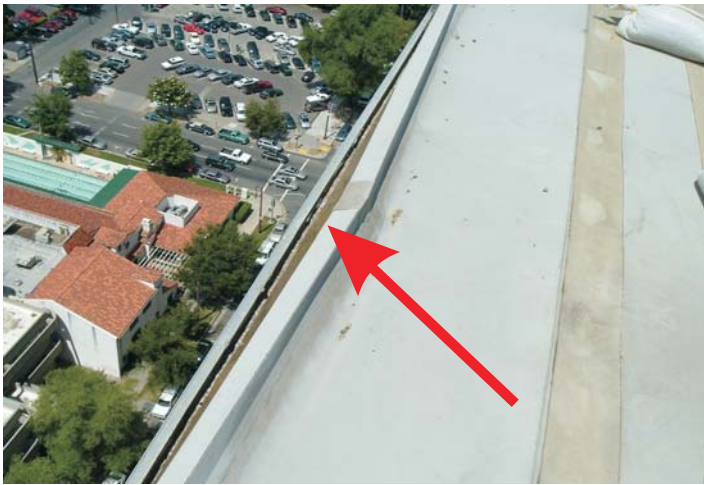
View of perimeter metal edging which failed during the winter storm.

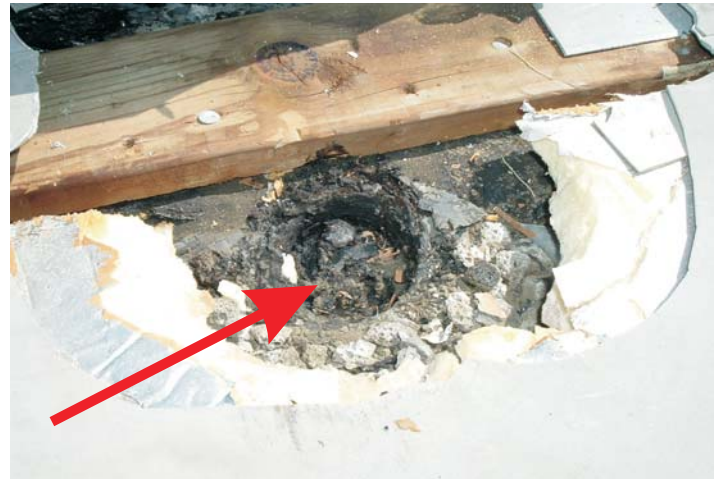
Original 2X6 redwood nailer can be seen at the bottom of this hole. 1x4 wood nailer had to be removed as well as the imbedded gravel for the installation of a new sheet metal edging.

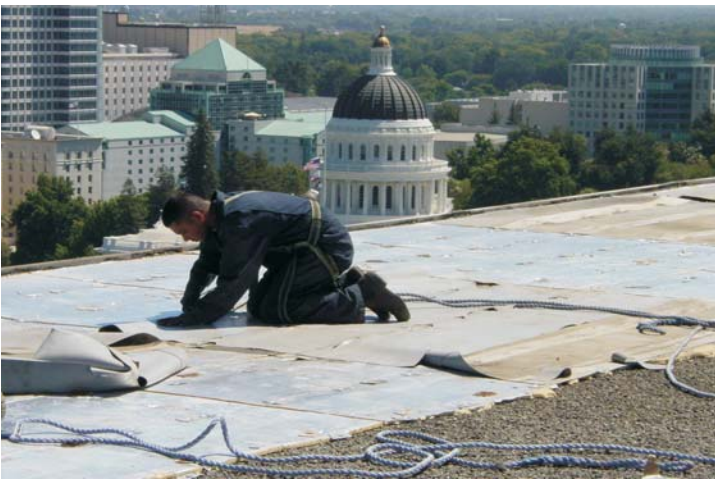
Tear-off involved the removal of the PVC membrane and the recovery board down to the original gravel surfaced roof. There were over 26,000 fasteners attaching the PVC membrane to the metal deck.

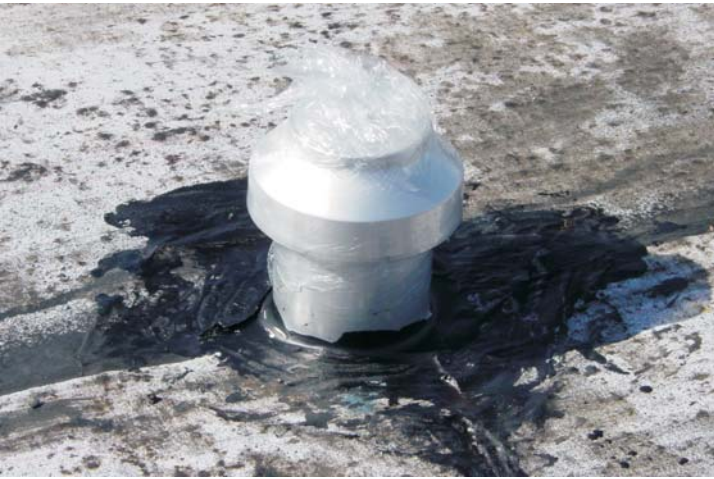
In order to ensure that no blistering takes place due to trapped moisture in the fiberglass insulation, a moisture scan was performed. In areas of wet insulation, 1 way pressure release vents were installed.
