View of the 275 foot high State Department of Water Resources Building. Housed within this building are Dept. Of Parks & Recreation, Fish & Game, Water Resources District and the Dept of Forestry & Fire Protection.

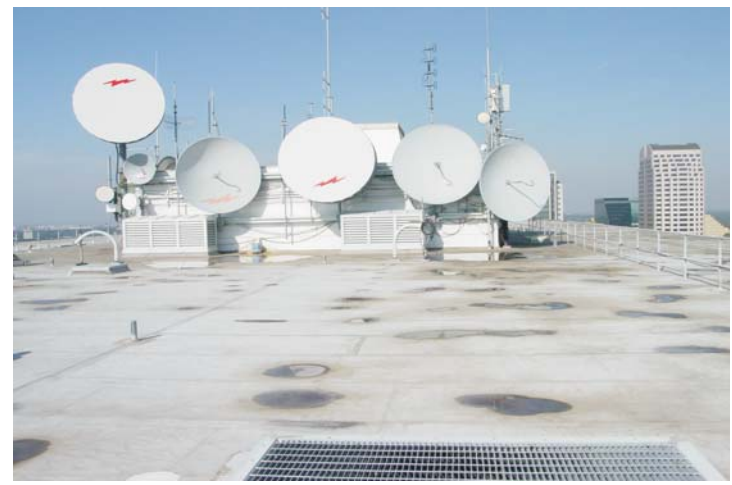
Since there are many critical state agencies resident in this facility, an asbestos abatement was considered unfeasible. The state asked for a work-around practice that could be proposed to waterproof this building without disruptions.

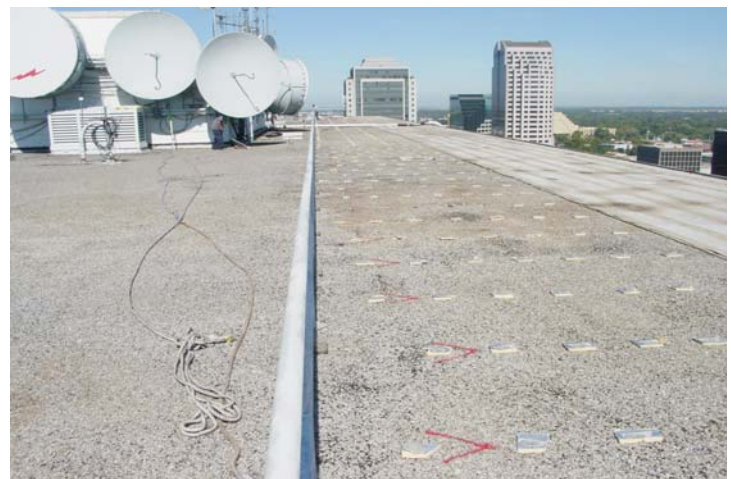
View of the progression of removal of the old PVC membrane from the northern perimeter to the area behind the safety rails.

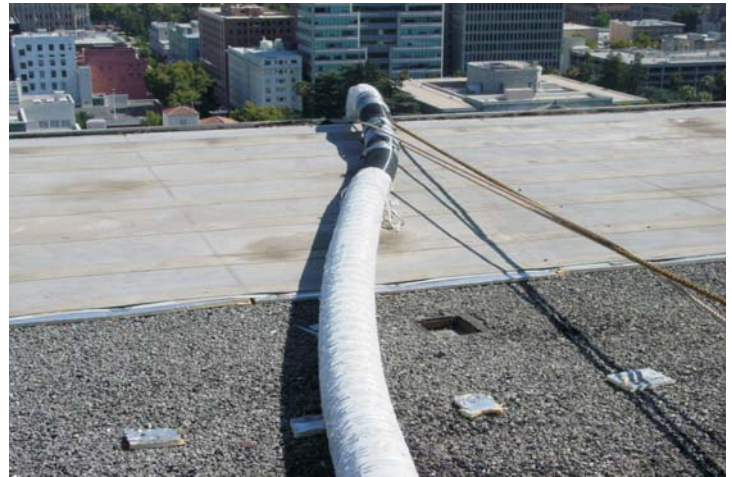
The vacuum hose was tied off at the mid section of the northern perimeter edge.

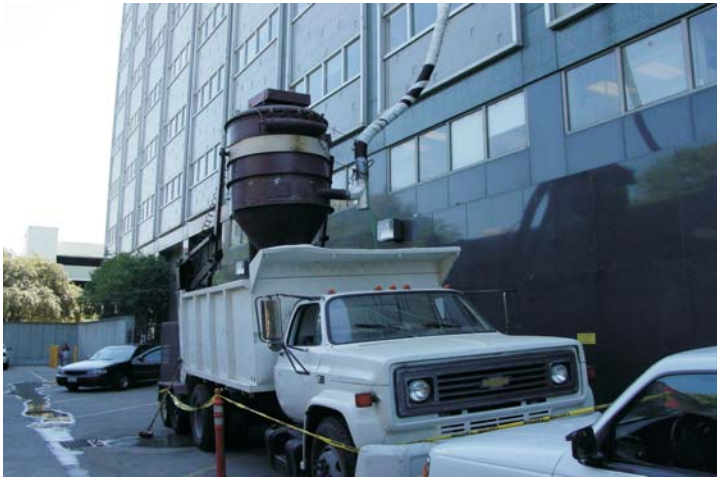
275 feet below, a large vacuum truck collects the gravel to be removed off-site.

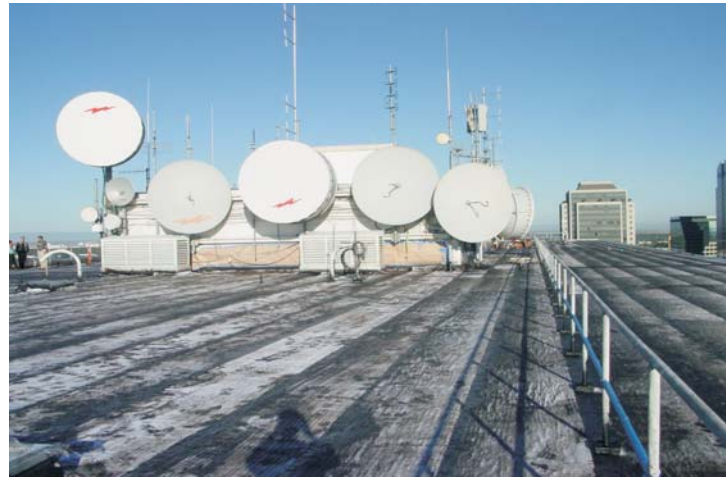
View of the polyester scrim as it cures out in the sun.

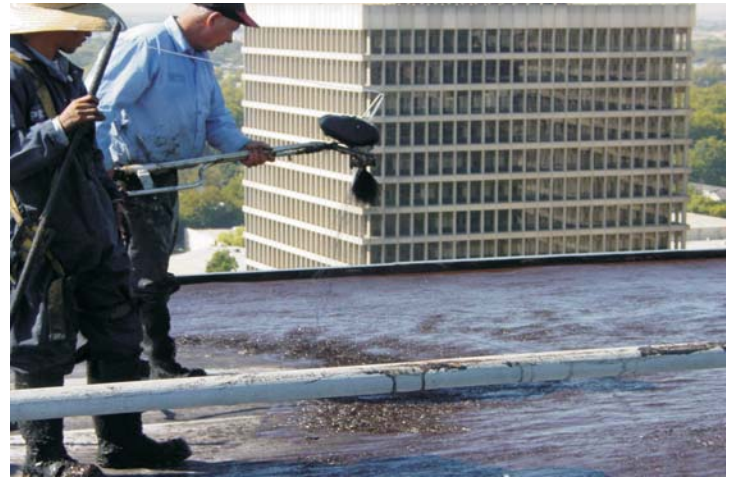
After 2 weeks of high temperatures and a follow-up scan, it was determined that the application of the seamless composite membrane could go forward.
