View of lower gravel roof section covering the main lobby, executive offices and hotel restaurants.

Also on this section, were planter boxes and multi-segmented skylights.

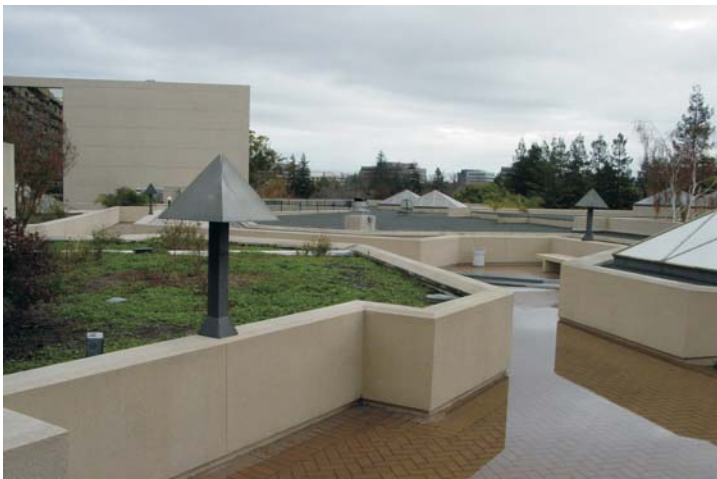
During winter rains, water ponded on the walkways and reports of major leaking into the restaurant and lobby sections required new waterproofing membranes.

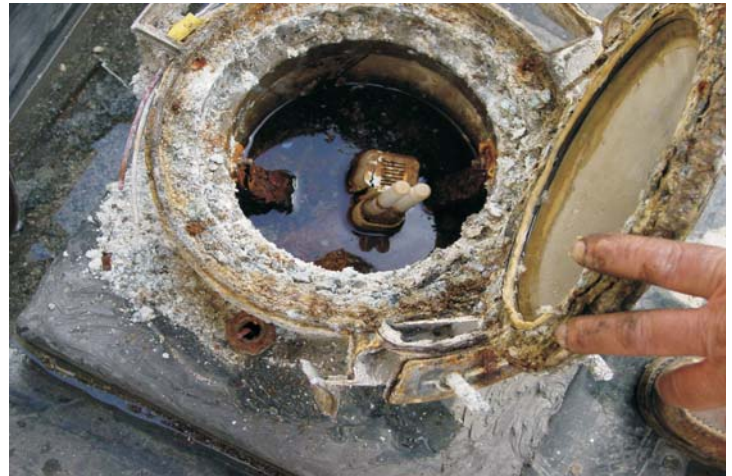
Investigation of the floodlights in the planter section revealed water entering behind corroded o-ring seals.

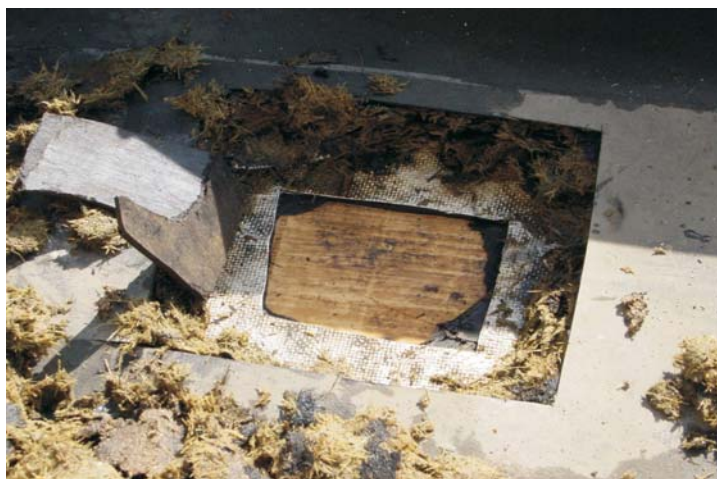
A test cut in the planter box reveals a plywood deck, followed by a 4 ply BUR, followed by a single ply membrane, followed by 1" fiberboard insulation, followed by an EPDM membrane. Insulation is saturated from years of water infiltration.

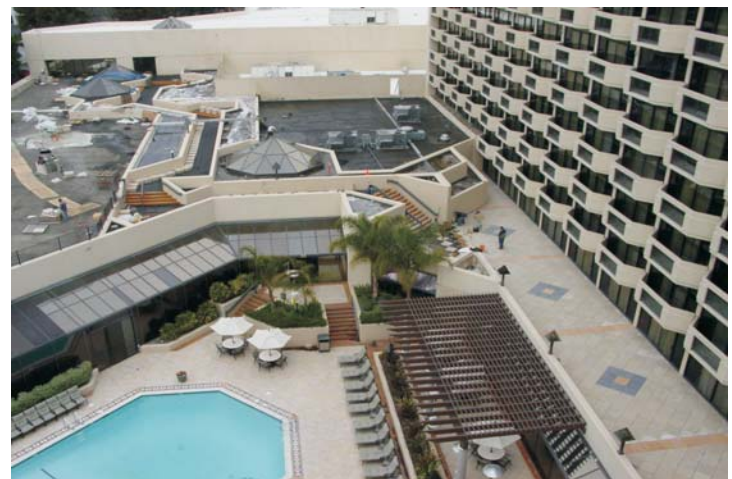
Working closely with the consultant and architect, it was determined that to correct the leaking problems, the planter boxes would need to be emptied and the existing membrane torn off to the deck. The roof deck would have its gravel surfacing removed, and a new WeatherWeld membrane installed.

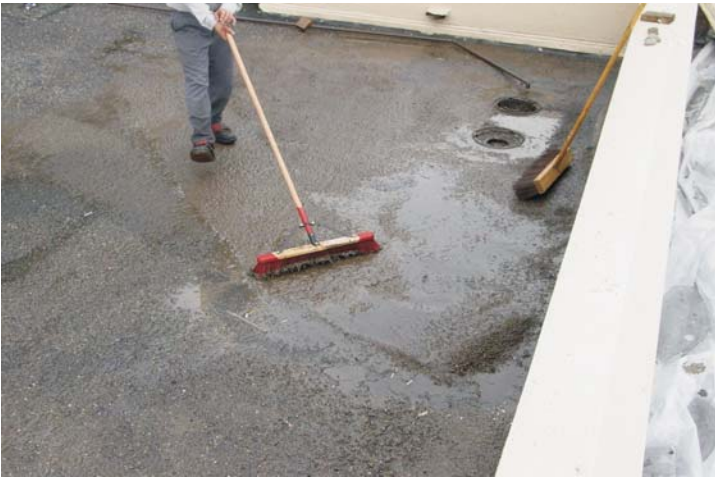
The gravel surfacing was broomed, vacuumed and broomed.
