Monroe Elementary School
 42-100 Yucca Lane
 Bermuda Dunes, CA 92201

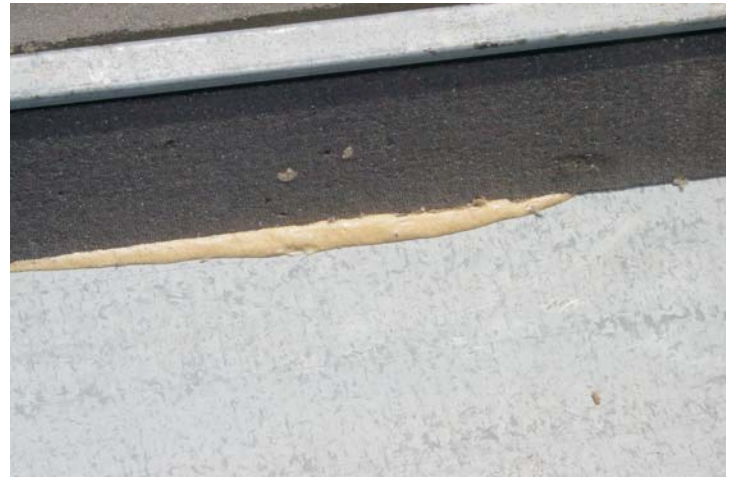
Metal standing-seam panels are power washed. Fasteners are tightened and missing ones replaced. #4 perlite cant strips are set in olybond adhesive against the standing seam.

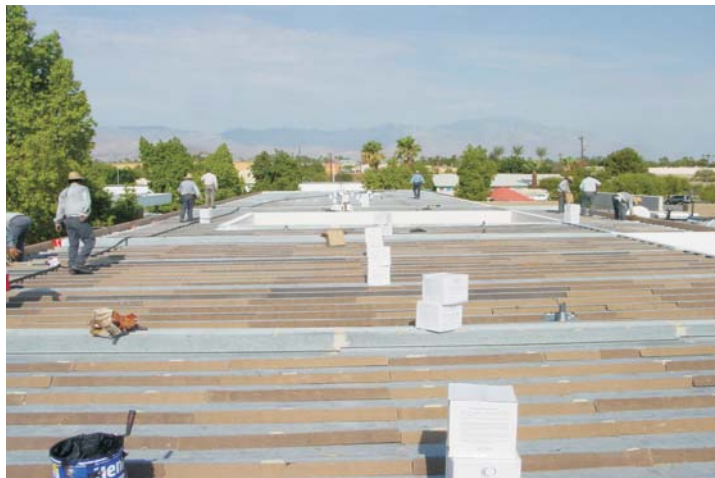
Continuos filament fiberglass roving boxes are set every 6 squares. Each application will have 8 lbs. of fiberglass per square.

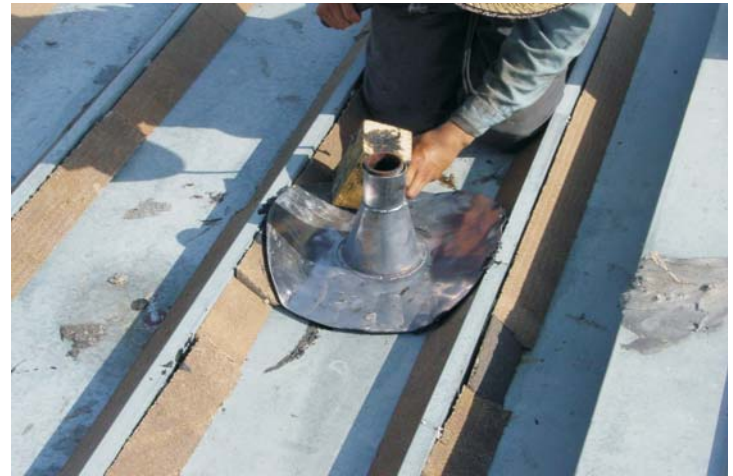
All pipe penetrations are flashed with a lead flashing which is set with mastic and covered with polyester and emulsion.

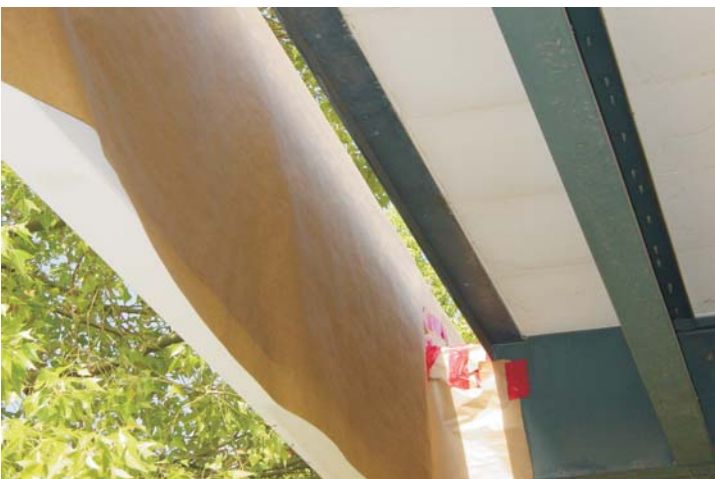
All exposed fascia are covered with masking paper to prevent over-spray on painted surfaces

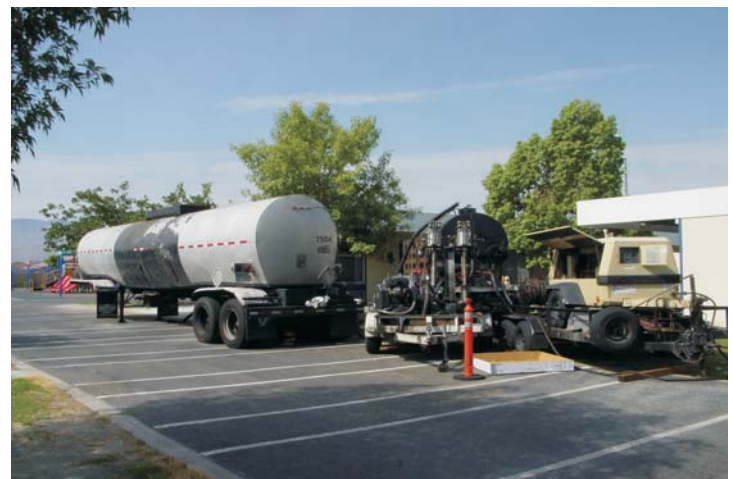
View of staged pneumatic pumping equipment along side a set of doubles containing approximately 6,000 gallons of high shear emulsion.

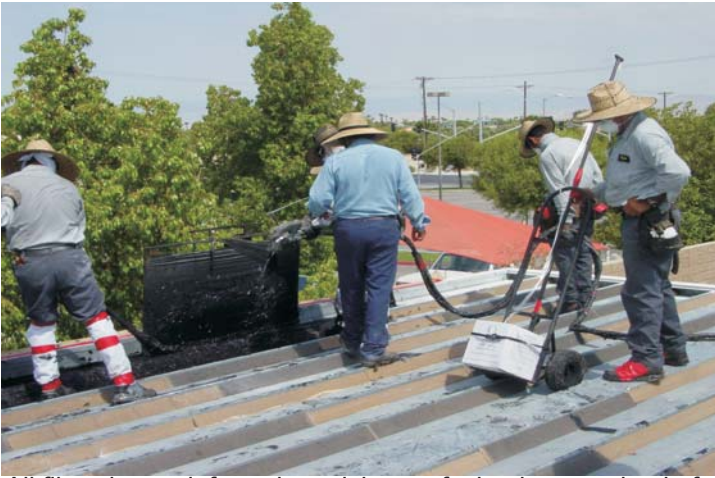
All fiberglass reinforced emulsion surfacing is comprised of a minimum of 30 gallons of high shear emulsion, uniformly and evenly disbursed within a 16 lb. application of multi-strand fiberglass per 100 square feet of roof area.

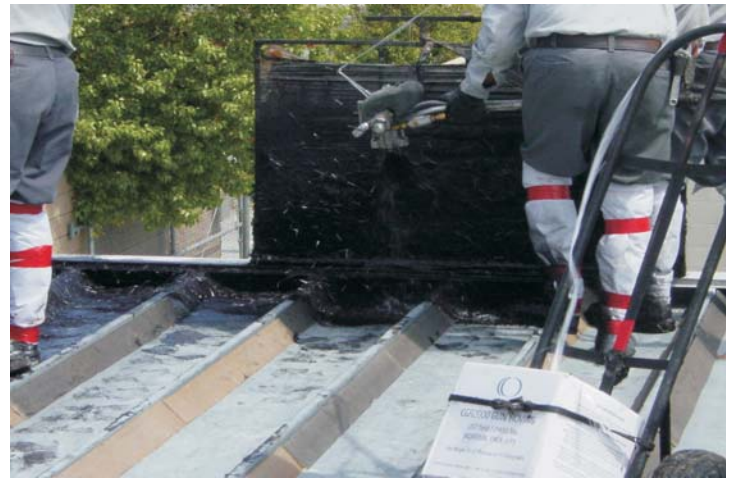
Fiberglass is disbursed from the applicator gun in lengths that range from 3/4" to 24" in length. Care is taken to prevent emulsion over spray, using a shield as seen in this view.

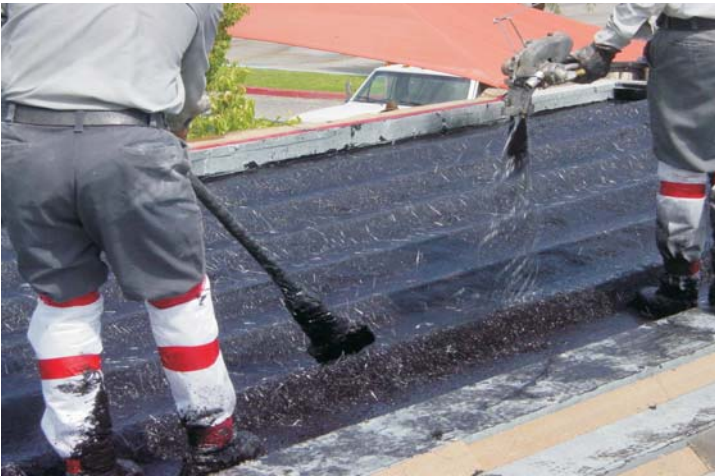
Both fiberglass and emulsion must be thoroughly mixed before coming in contact with the roof deck. Excess emulsion is being pulled out of the composite to prevent surface crazing.

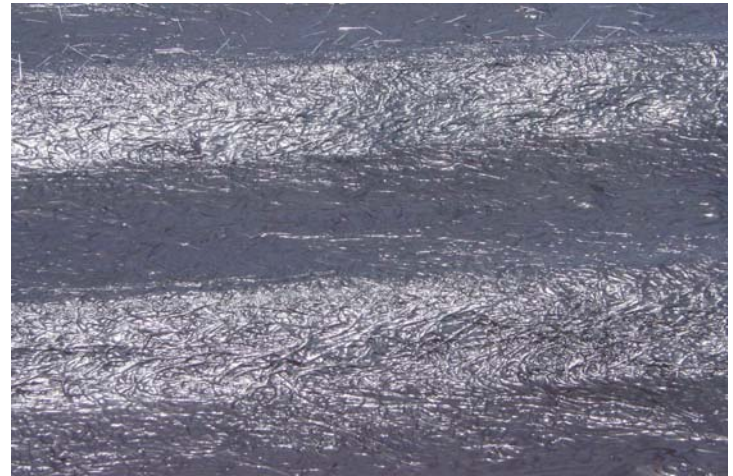
Over 2.2 miles of fiberglass reinforcement, encapsulated in the asphalt emulsion, is contained in every square foot of the finished seamless composite membrane.

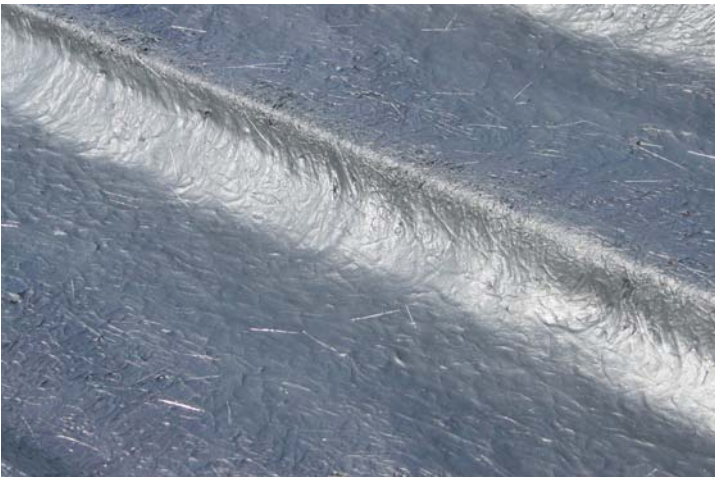
The seamless composite is able to conform to both the flat pan surfaces as well as all the compound angles in this standing seam assembly.

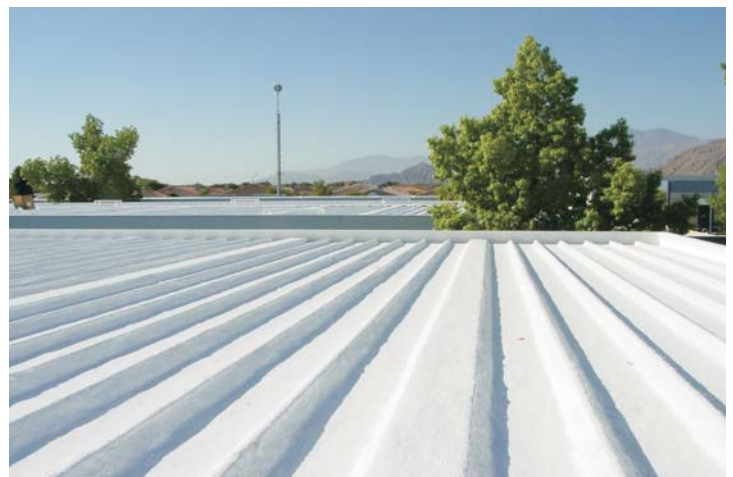
This experienced WeatherWeld contracting crew is capable of completing approximately 10,000 square feet of seamless composite roofing per day. On the finished membrane, a Title 24 compliant white "Cool Roof" coating is applied.
