WeatherWeld
SEAMLESS COMPOSITE ROOFING

Project, 150,000 square feet of BUR set in hot asphalt, mechanically attached to a plywood deck. Building is used to manufacture vitamins...must be kept very clean!

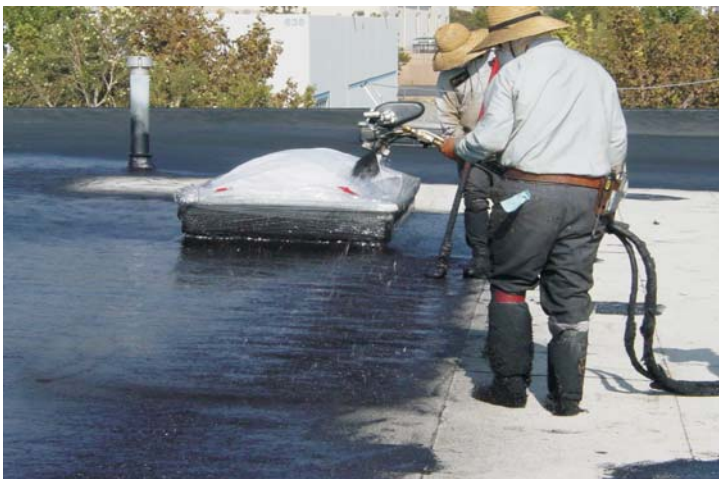
Since a tear-off was not an option, and VOC's, odors and dust were a major concern, the facility's management team selected the WeatherWeld Seamless Composite System.

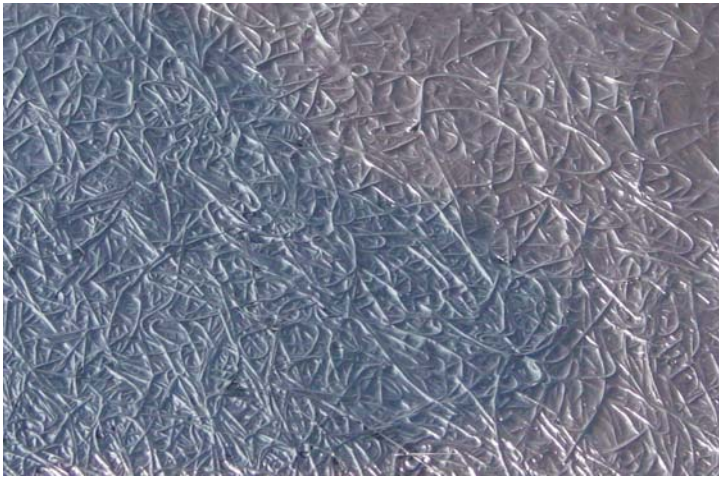
2.2 miles of fiberglass reinforcement, encapsulated in the WeatherWeld 121 asphalt emulsion, is contained in every square foot of the seamless composite membrane.

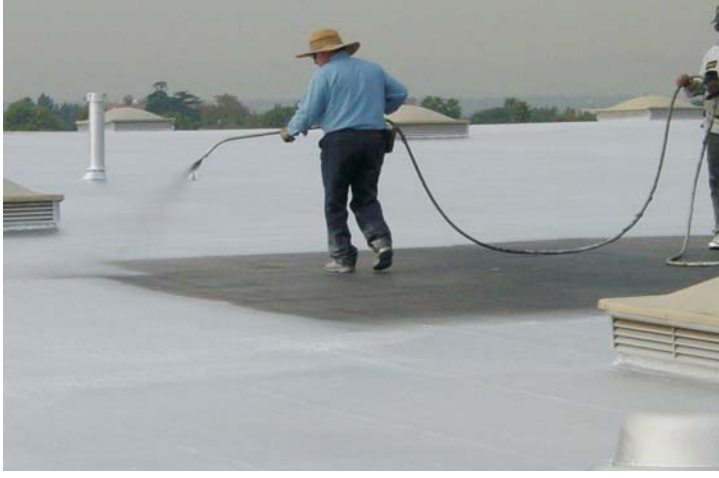
Upon drying, a highly reflective asphalt aluminum coating is applied.

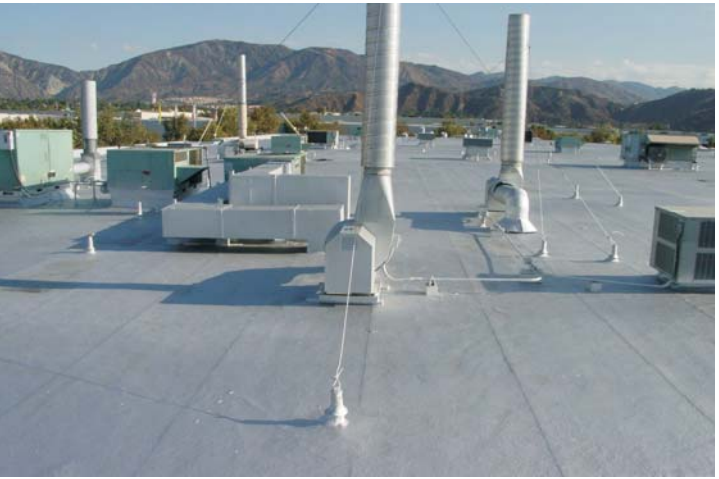
This finished WeatherWeld Seamless Composite membrane has 1.5 times the amount of reinforcement of a 4 ply BUR; over twice the thickness of a single ply, and 10 times the tear strength of a polyester and emulsion system!
